Building stone of Hollybush Church

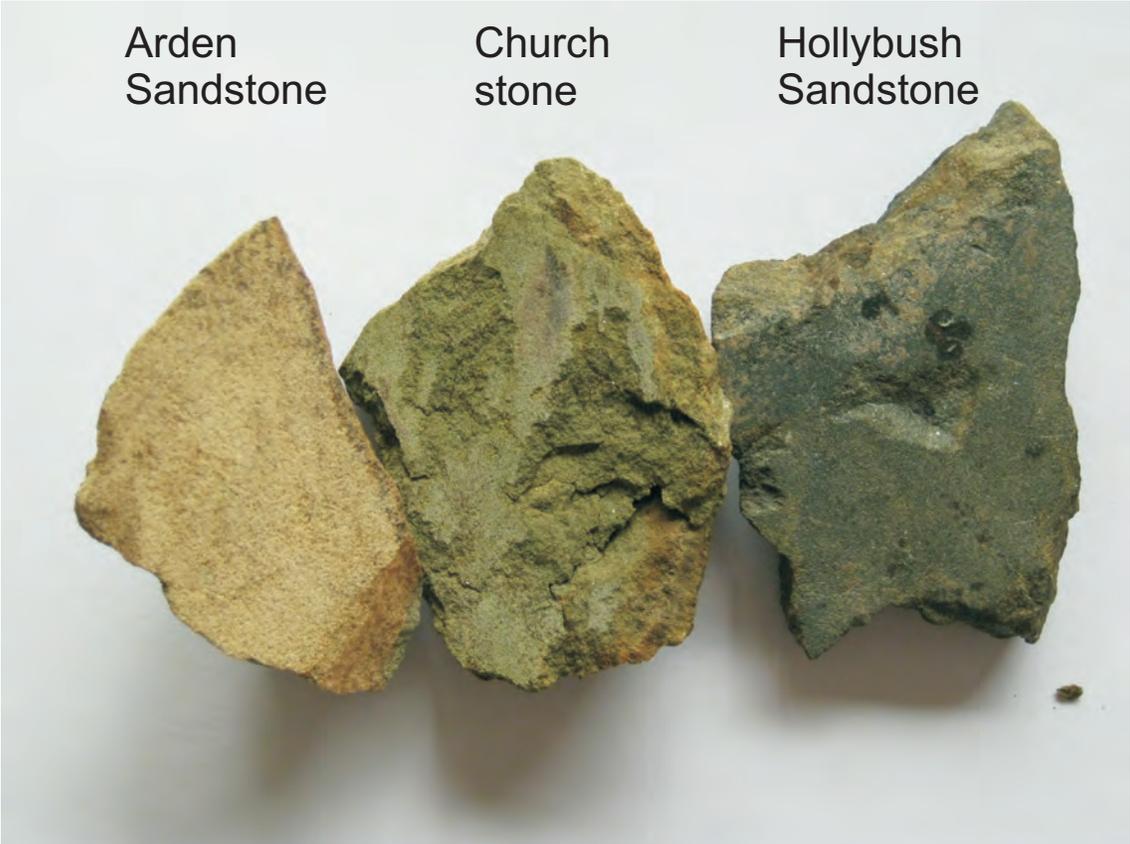
- 3 A flat surface was ground on each sample using an angle grinder
and was washed (using detergent) to remove grinding debris.
- 4 The samples were photographed together, with colour correction for the spectrum of the illumination.
i.e. the illumination was effectively white light.
(Figure 1)

- 6 A small area of each photograph was enlarged, better to show the grain structure.
(Figure 3)
- 7 The colours of the samples were noted
Figure 1 was simply analysed by sampling the colour as red/green/blue (RGB) number at a few points and averaging
The ratios green/red and blue/red were calculated.

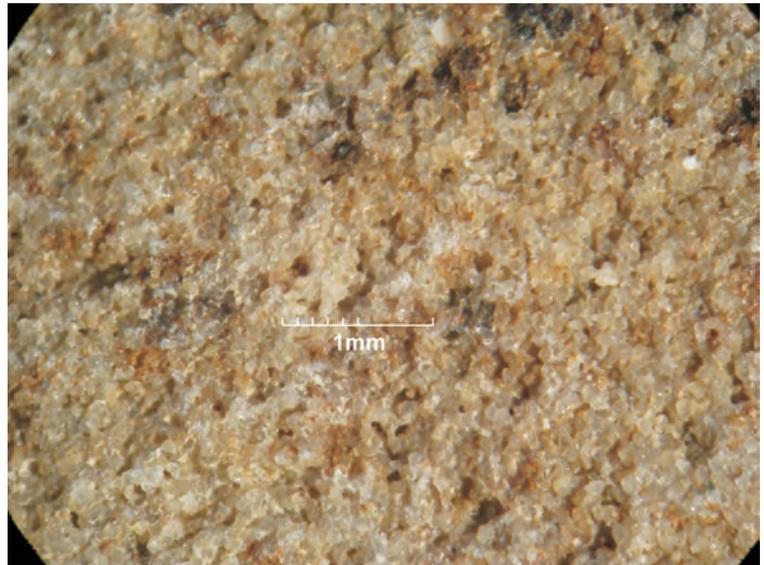
Arden Sandstone

- 5 Each ground surface was photographed under x20 magnification
Colour correction was applied
Intensity correction was not applied so all pictures show the same average brightness
despite the variations in sample shade
(Figure 2)

(all frames
are 5mm wide)

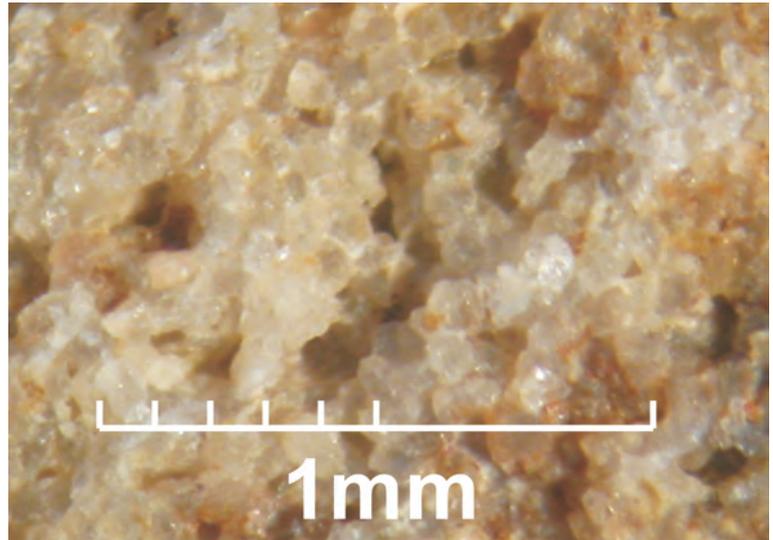
Arden Sandstone

Figure 3 shows it to be composed largely of uncoloured quartz crystals, well sorted and of size about 100 microns

Figure 3 shows the large voids which lead to the high porosity.

- 8 The approximate grain size and degree of sorting were estimated from Figure 3
- 9 Sample porosity was tested using water drops
- 10 Reaction to dilute HCl was tested

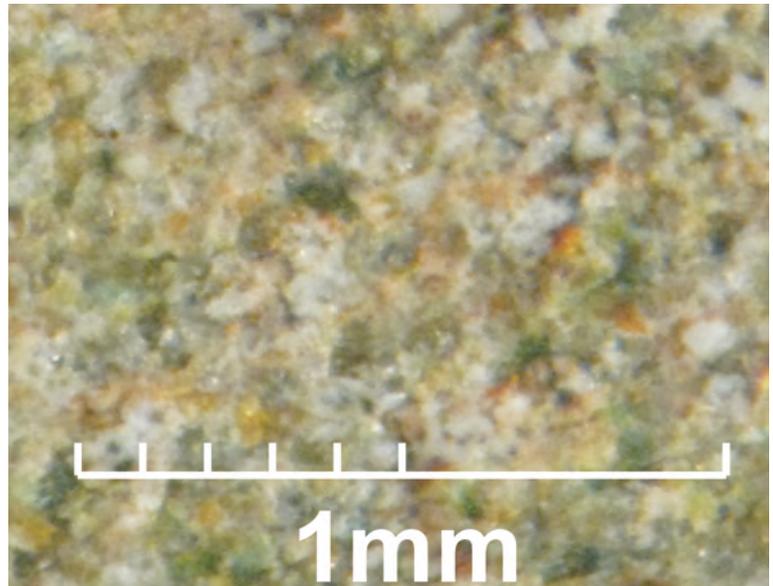
Hollybush Church
stone

This has properties lying generally between those of the other two stones so the question of which it is related to is not straightforwardly answered.

It contains considerable amounts of material other than quartz and not derivable from quartz.

It has very small or no porosity, quite unlike the Arden Sandstone sample.

Its visual colour is distinctly greenish, suggesting a chlorite component larger than in the Hollybush Sandstone. Chlorite is a common weathering product of mafic minerals so its presence suggests that the church is of weathered Hollybush Sandstone.

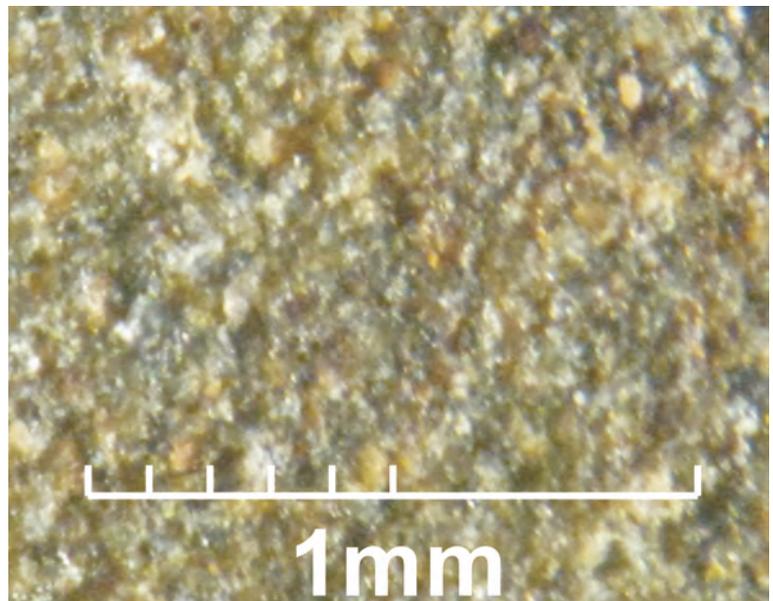
Hollybush
Sandstone

Figure 3 shows it to have a high proportion of dark (mafic) minerals.

The crystals are poorly sorted, with largest size about 40 microns.

Figure 3 shows the rock to be essentially free of voids.
